# Manhole Inspection Summary

Manhole # S45U1\_001MH

Insp Date: **11/2/08 2:51 PM**

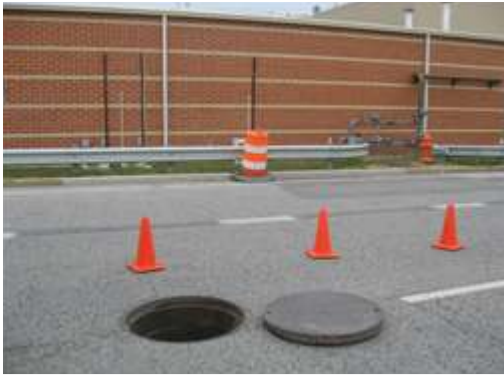
Location View

1205 Frankfurst Ave.

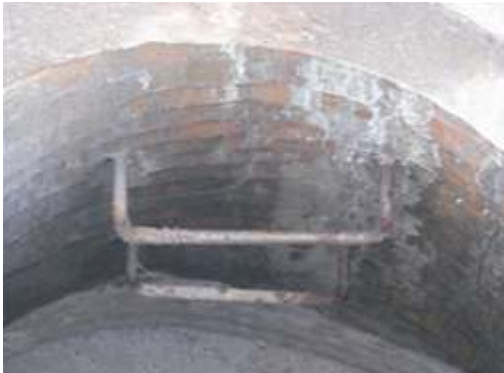
Steps

Count: **2** Missing: **0** ☐ Corroded

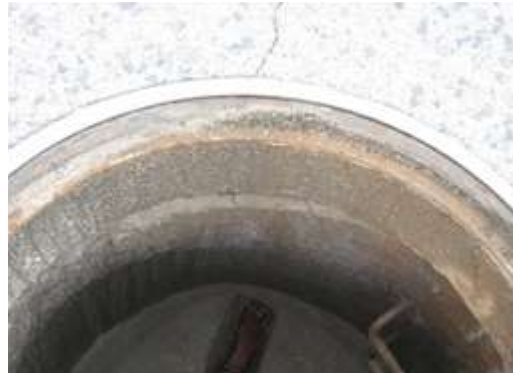
Defect 1

Offset: **2** (in.)

Frame Offset

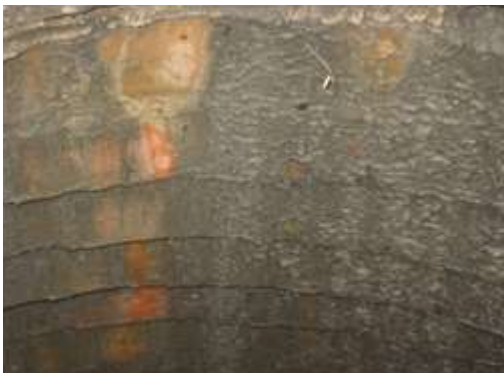
Defect 2

Condition: ☐ Sound ☒ **Cracked** ☐ Root Intrusion ☐ Loose Brick ☐ Deteriorated

Infiltration: ☐ None ☒ **Joint** ☐ Cracks ☐ Mortar ☐ Roots ☐ Wall

Leakage

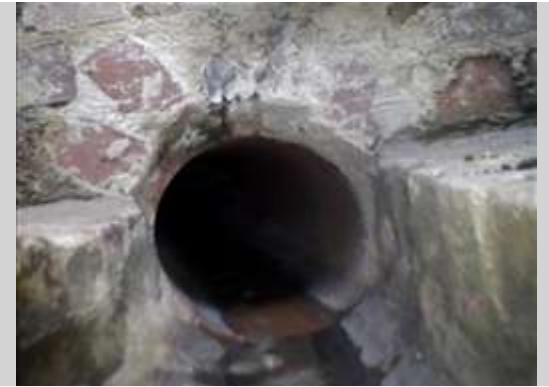
12 O'Clock Outflow

8 in. Circular Gravity Sewer  
Pipe Out @ 12 O'Clock

Pipe Height: **8.4** (in.) Rod and Bar (Angled)  
Pipe Material: **Clay** ☐ Pipe Lined  
Invert Depth: **6.30** (ft.) Flow Characteristics: **Slow**  
Deposits: ☒ None ☐ Mud ☐ Sludge ☐ Debris ☐ Grease  
Silt Depth: (in.) Deposits Extent:  
Infiltration: **Evidence** Pipe Seal Cond: **Sound**

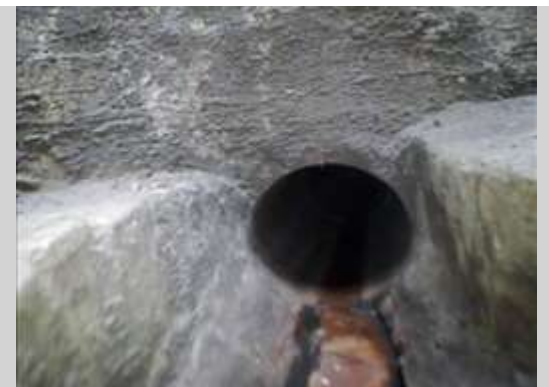
8 O'Clock Inflow

8 in. Circular Service Sewer  
Pipe In @ 8 O'Clock

Pipe Height: **7.2** (in.) Rod and Bar (Angled)  
Pipe Material: **Clay** ☐ Pipe Lined  
Invert Depth: **6.16** (ft.) Flow Characteristics: **None**  
Deposits: ☒ None ☐ Mud ☐ Sludge ☐ Debris ☐ Grease  
Silt Depth: (in.) Deposits Extent:  
Infiltration: **None** Pipe Seal Cond: **Sound**
